Preliminary Arborist Report **and Protected Tree Inventory**

John Adams Academy
1 Sierragate Plaza
Roseville, CA

March 23, 2017

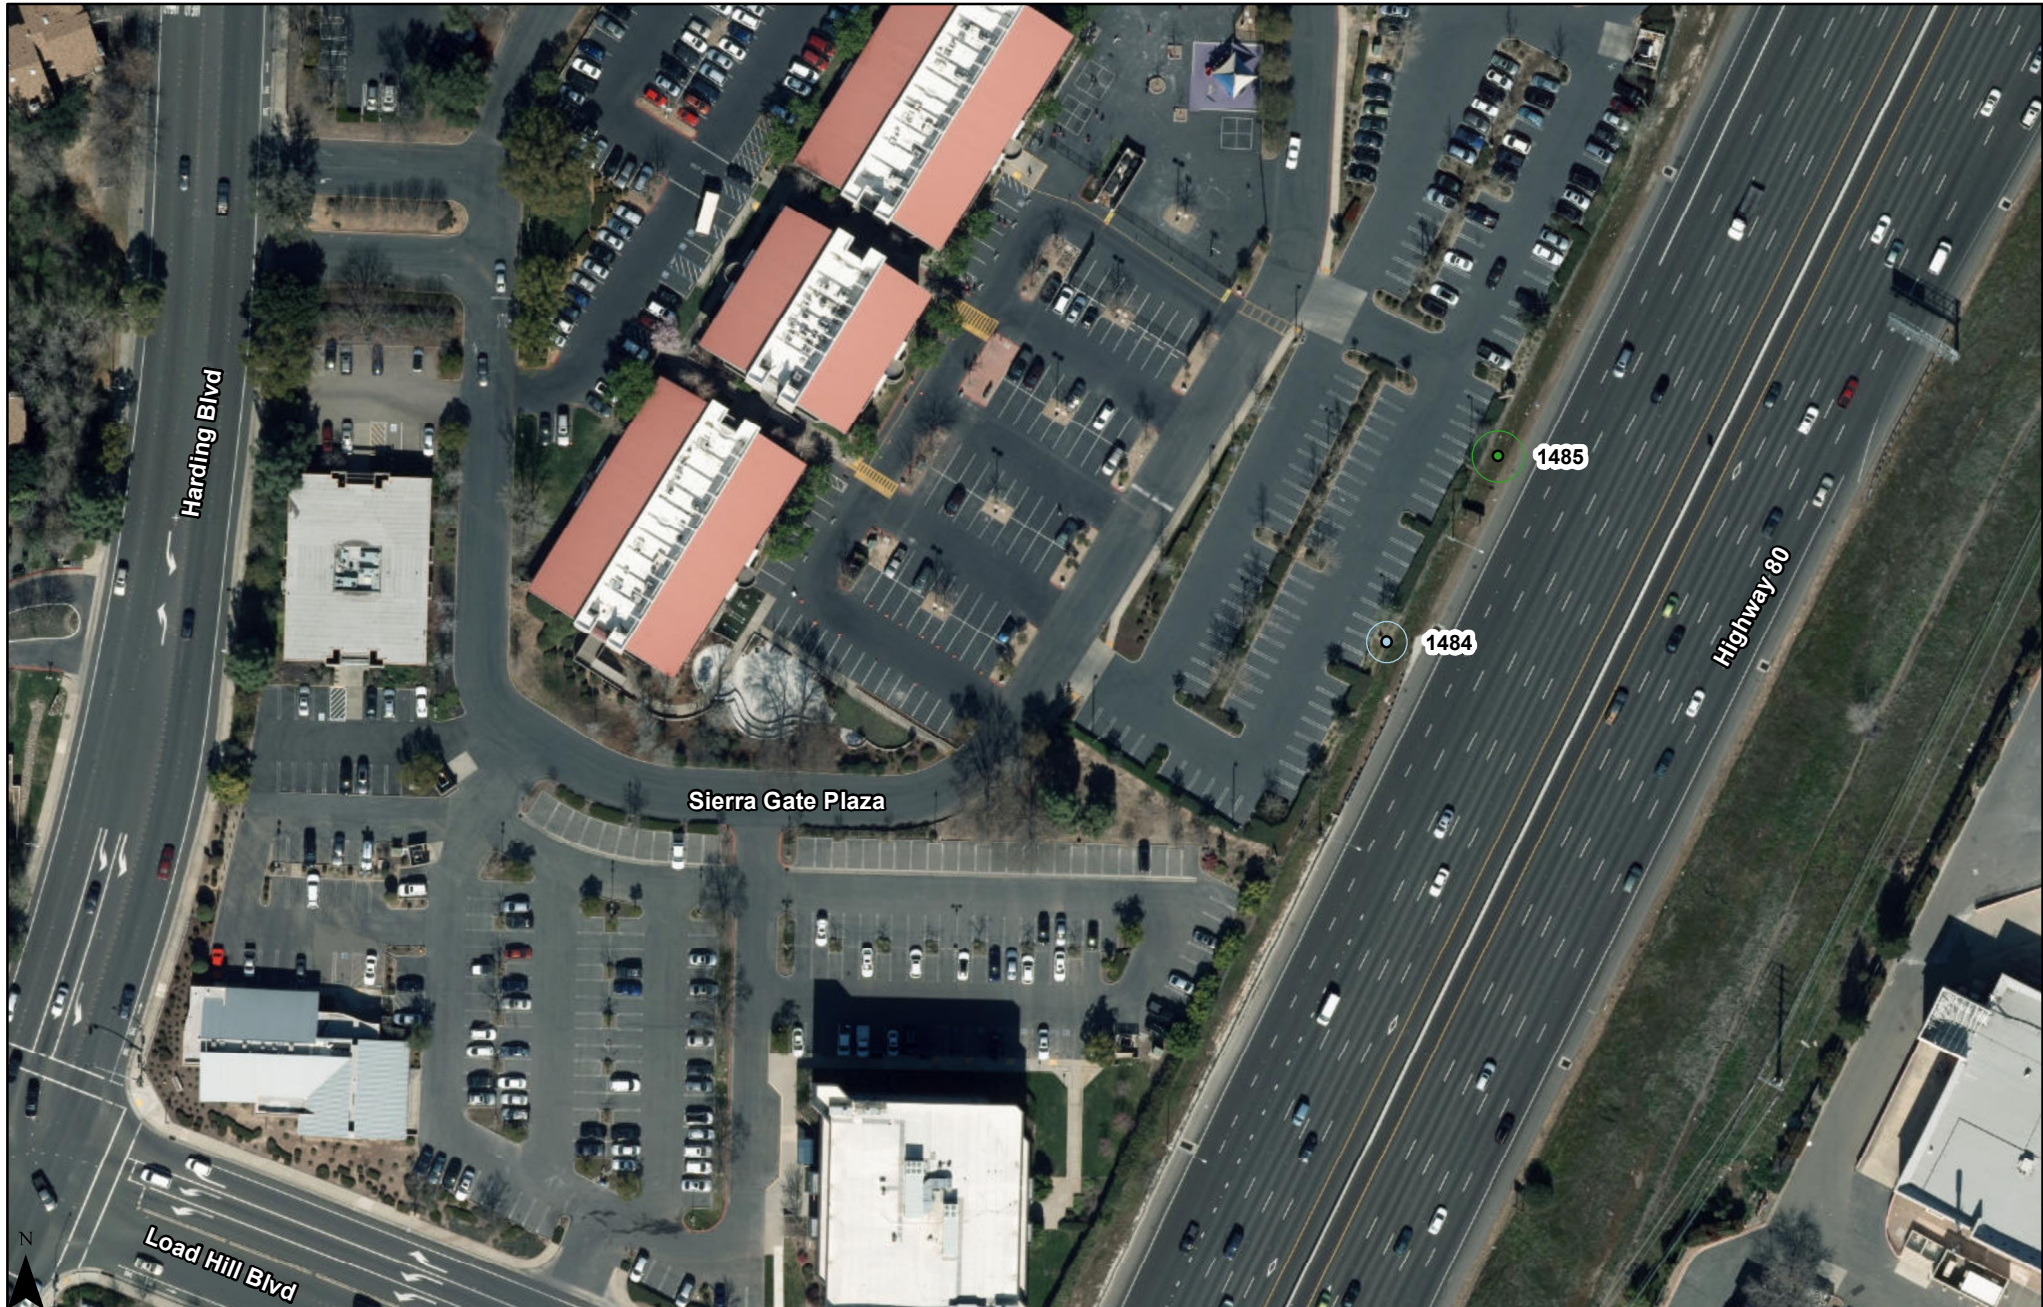
Tree Rating

- 3 Fair - Minor Problems
- 4 Good - No Apparent Problems

Tree Canopy

- 3 Minor Problems
- 4 No Apparent Problems
